Automatic Light Aircraft Readiness Monitor  
Project ALARM

VOLUME III

**Project ALARM**  
**AUTOMATIC LIGHT AIRCRAFT READINESS MONITOR**  
**Phase II Test Program**

**VOLUME III**  
**ADDENDUM - REINSTALLATION**

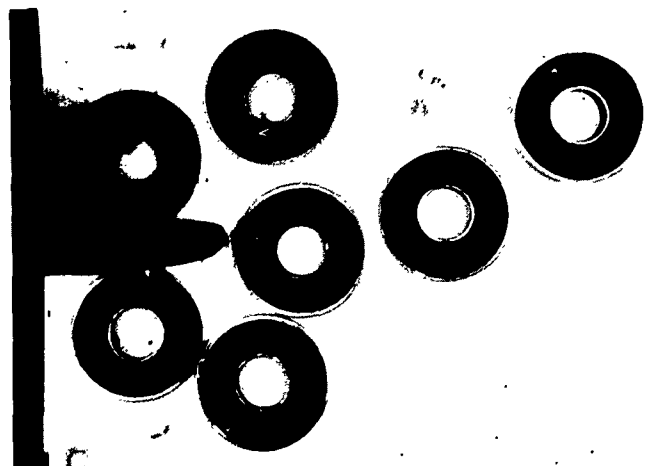
This section contains basic photographic documentation of certain specific component reinstallations. Figure 7 and Figure 8 are photographs showing evidence of accumulation of metal particles in the Engine Oil Filter. This condition was discovered during the process of reinstalling the new-type filter which contained the ALARM sensors.

**Figure 8. Engine Oil Filter Screens (Shows evidence Of Metallic Particles After Engine Overhaul).**
